SITE ASSESSMENT REPORT
FOR
WESTBANK ASBESTOS
MARRERO, JEFFERSON PARISH, LOUISIANA

September 27, 1991

J. Chris Petersen
Deputy Project Officer
Emergency Response Branch
EPA - REGION 6

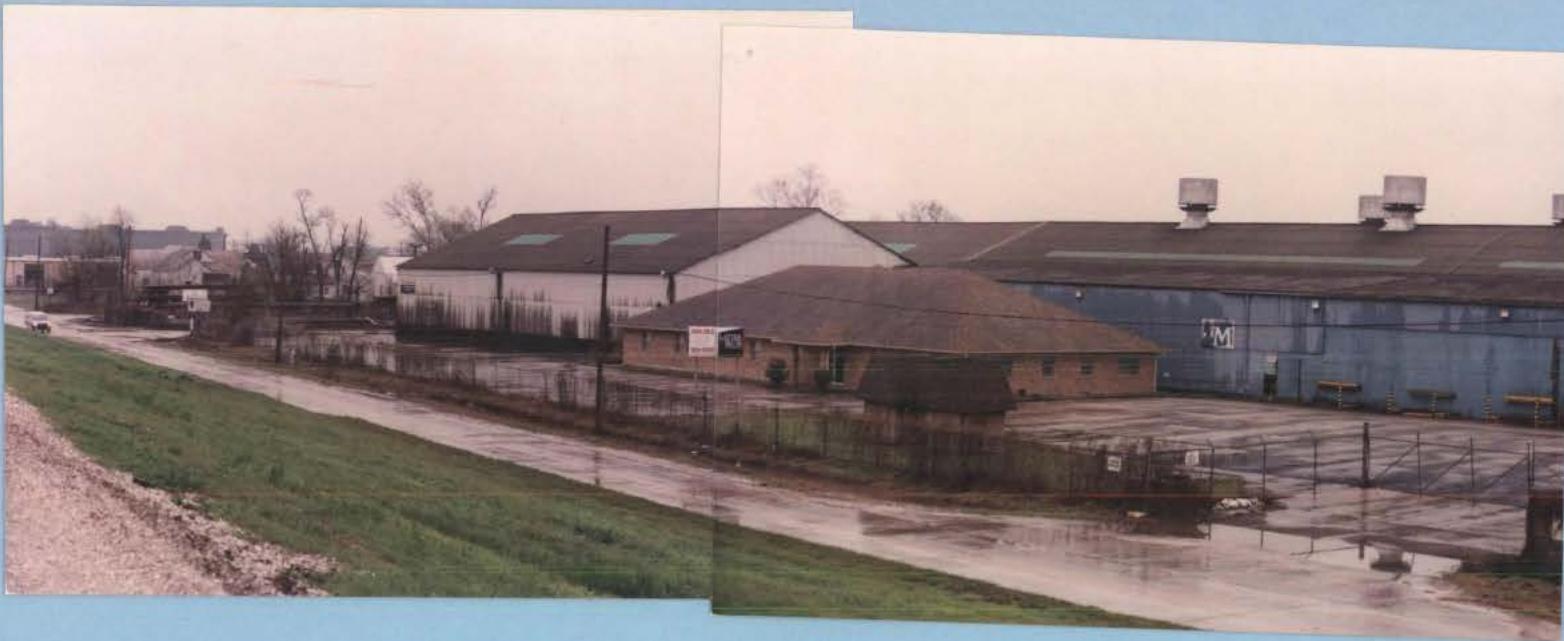
PHOTO #'s: 1-2 DATE: 02/08/90
TIME: 1556 DIRECTION: SE
PHOTOGRAPHER: T. NAQUIN/R. FERRELL

PANORAMA OF JOHNS-MANVILLE PLANT

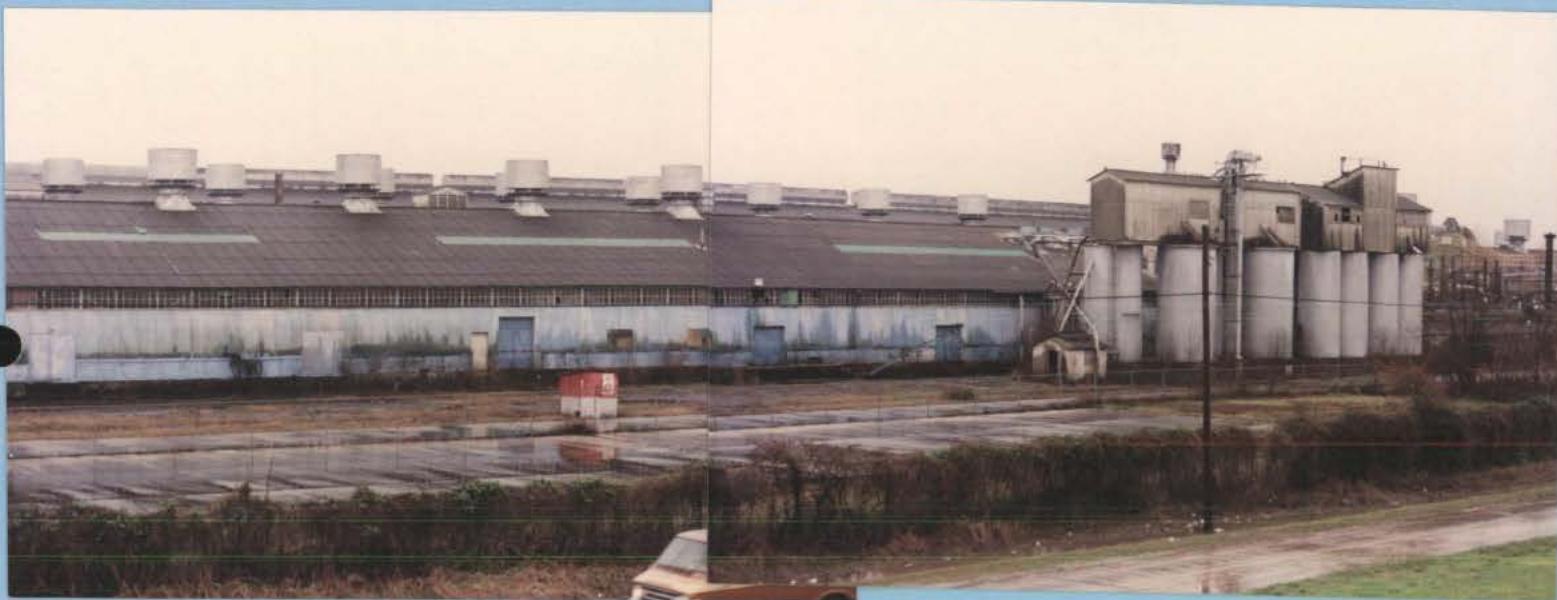
PHOTO #'s: 3-4 DATE: 02/08/90
TIME: 1556 DIRECTION: SE-S
PHOTOGRAPHER: T. NAQUIN/R. FERRELL

PANORAMA OF JOHNS-MANVILLE PLANT

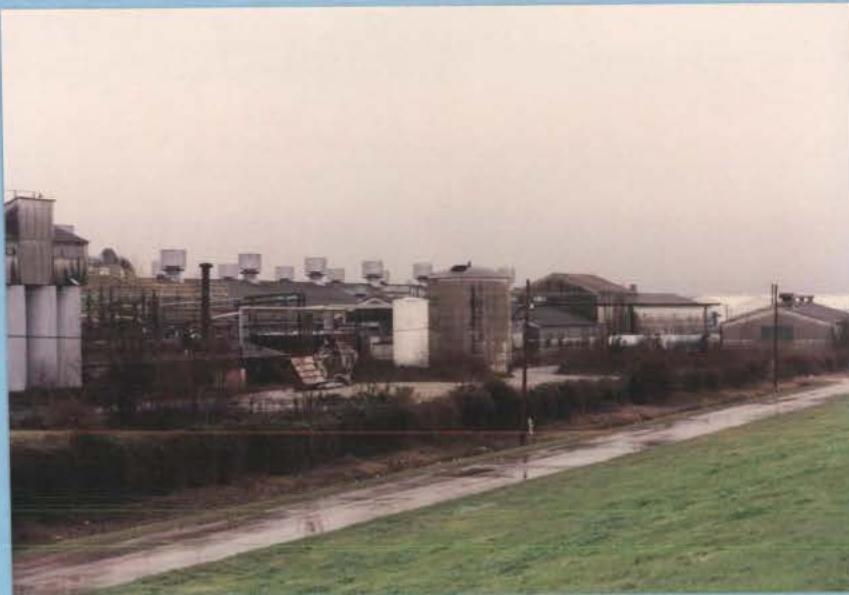
PHOTO #'s: 5-6 DATE: 02/08/90
TIME: 1556 DIRECTION: S-SW
PHOTOGRAPHER: T. NAQUIN/R. FERRELL

PANORAMA OF JOHNS-MANVILLE PLANT

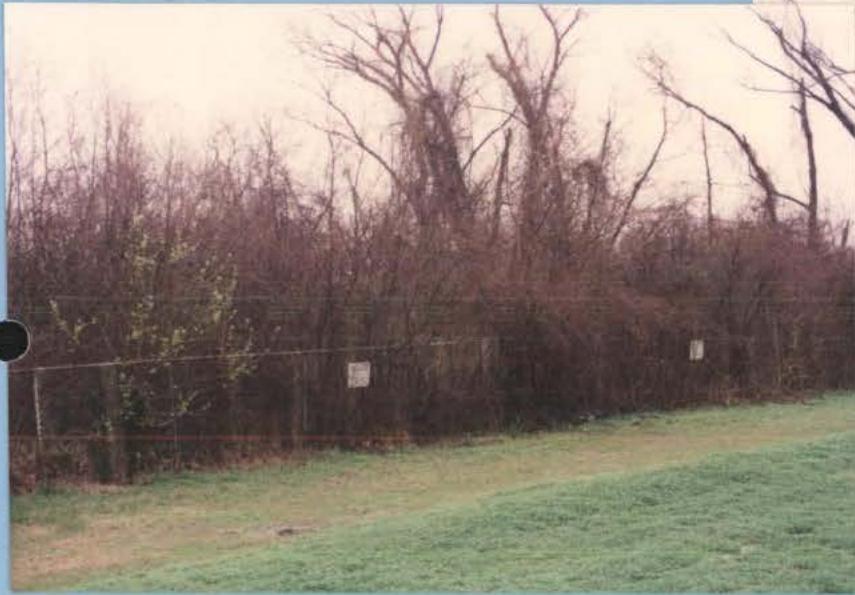
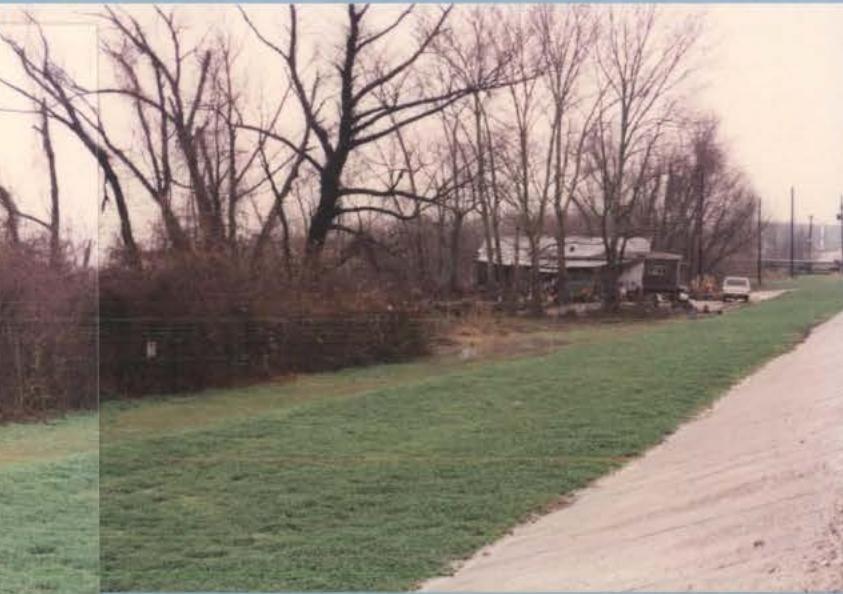
PHOTO #: 7 DATE: 02/08/90
TIME: 1556 DIRECTION: SW
PHOTOGRAPHER: T. NAQUIN/R. FERRELL

PANORAMA OF JOHNS-MANVILLE PLANT

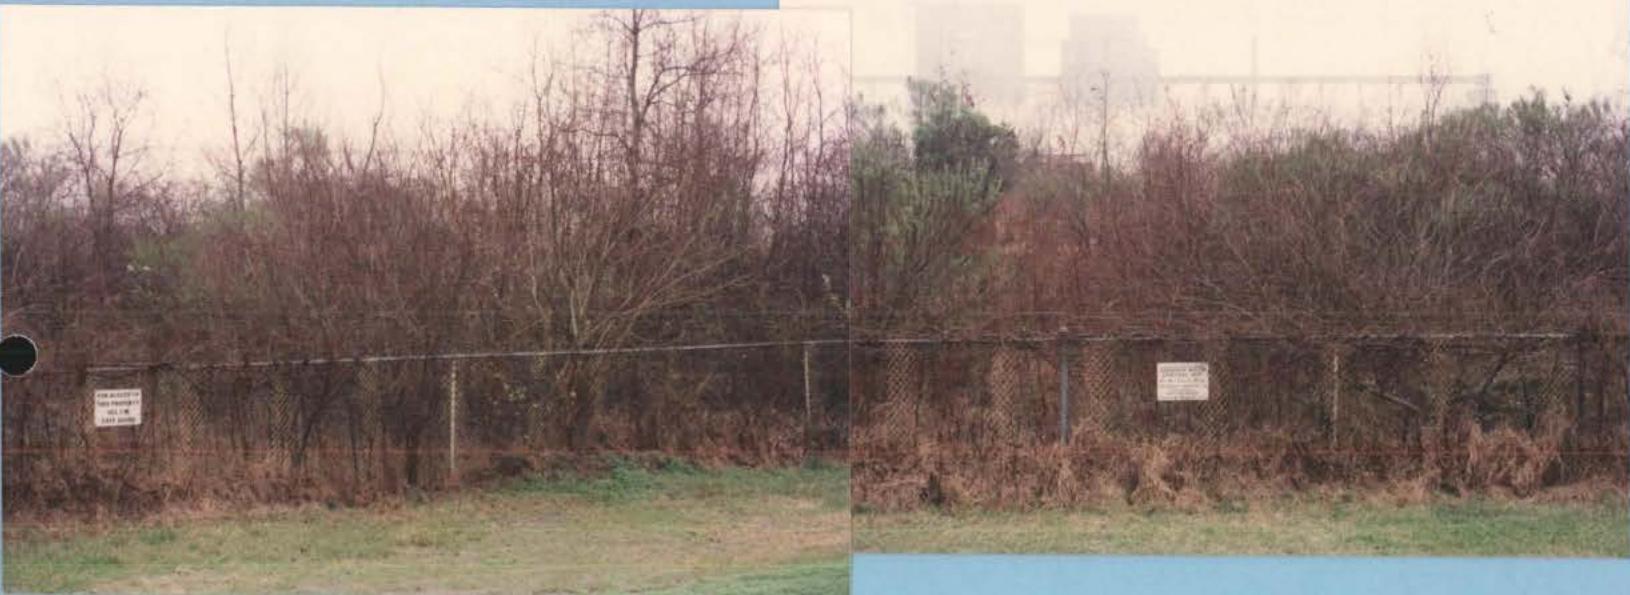
PHOTO #'s: 10-11 DATE: 02/08/90
TIME: 1558 DIRECTION: NE-N
PHOTOGRAPHER: T. NAQUIN/R. FERRELL

PANORAMA OF JOHNS-MANVILLE LANDFILL ON THE
WESTBANK OF THE MISSISSIPPI RIVER

observed possible ACM outcropping in the ditch below the pipeyard along River Road (Photograph 33 - 36). North of the plant on the battice was another landfill used by Johns-Manville (Photograph 8 - 14). This fenced landfill was heavily vegetated and posted with asbestos warning plaques (Photograph 15). LDEQ informed TAT that a municipal water intake for the city of Marrero was located 0.5 miles downstream from the landfill on the westbank of the Mississippi River. TAT and LDEQ noted that the landfill was inundated with several feet of water during a high flood stage, and the fence had an open gate at the southeast corner (Photograph 20 - 21).

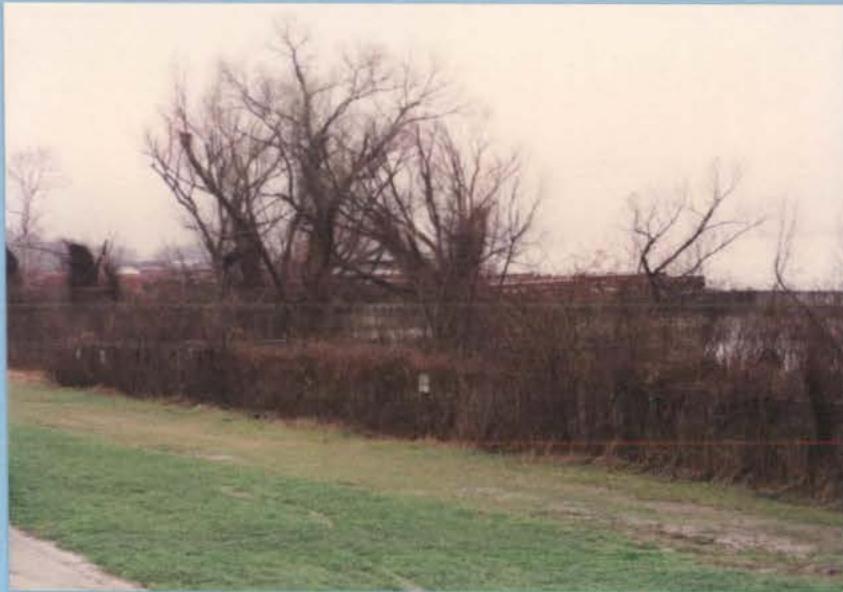
PHOTO #'s: 12-13 DATE: 02/08/90
TIME: 1558 DIRECTION: N-NW
PHOTOGRAPHER: T. NAQUIN/R. FERRELL

PANORAMA OF JOHNS-MANVILLE LANDFILL ON THE
WESTBANK OF THE MISSISSIPPI RIVER

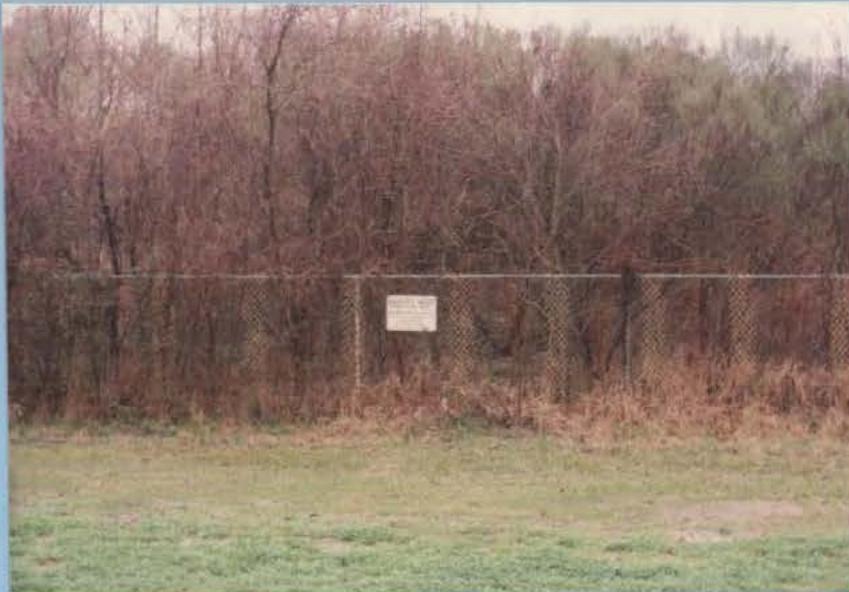
PHOTO #'s: 14 DATE: 02/08/90
TIME: 1558 DIRECTION: NW
PHOTOGRAPHER: T. NAQUIN/R. FERRELL

PANORAMA OF JOHNS-MANVILLE LANDFILL ON THE
WESTBANK OF THE MISSISSIPPI RIVER

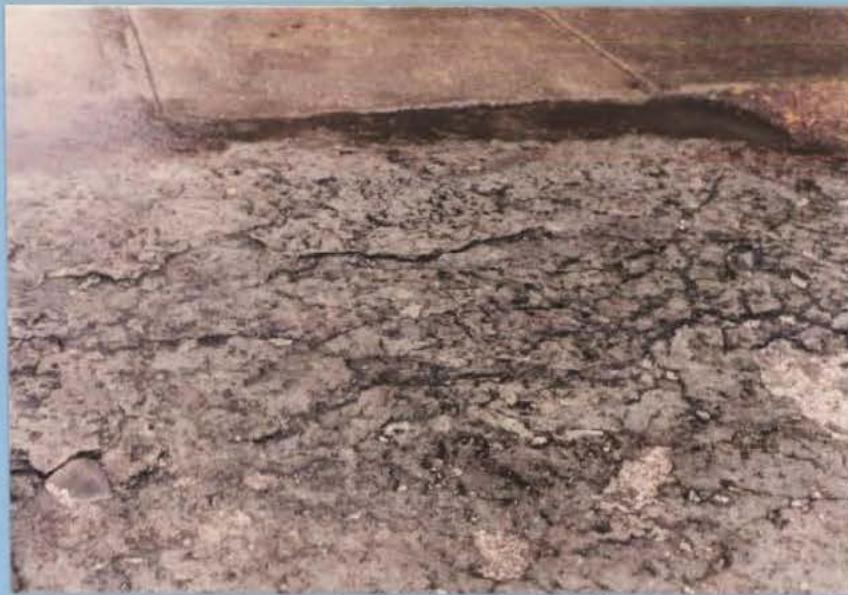
PHOTO#: 16 DATE: 02/08/90
TIME: 1610 DIRECTION: DOWN
PHOTOGRAPHER: J. MARTIN/T. NAQUIN

(b) (6)
LDEQ SAMPLE [REDACTED]
WESTWEGO, LA

During the reconnaissance of the cities of Westwego, Marrero, and Gretna, TAT observed ACM in the driveways of the residences which had a light to medium gray, cementitious appearance (Photographs 16 - 19) and in some areas appeared to be one to three inches thick (Photograph 22). Found mixed in with the ACM were various asbestos products such as transite pipe (Photograph 23). The extent of ACM contamination was undetermined by LDEQ and TAT during the drive-by inspections.

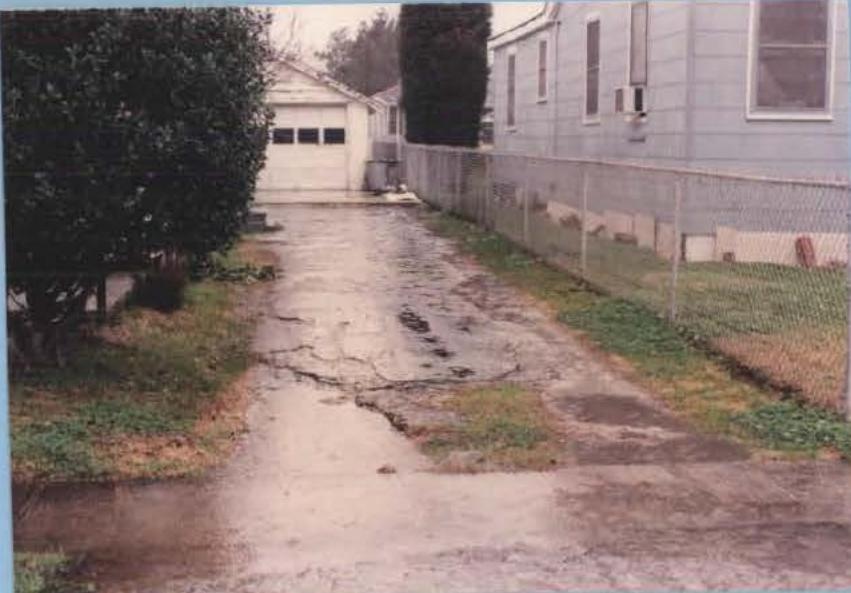
PHOTO#: 17 DATE: 02/08/90
TIME: 1614 DIRECTION: W
PHOTOGRAPHER: J. MARTIN/T. NAQUIN
(b) (6)

DRIV [REDACTED] SUSPECTED OF
CONTAINING ASBESTOS

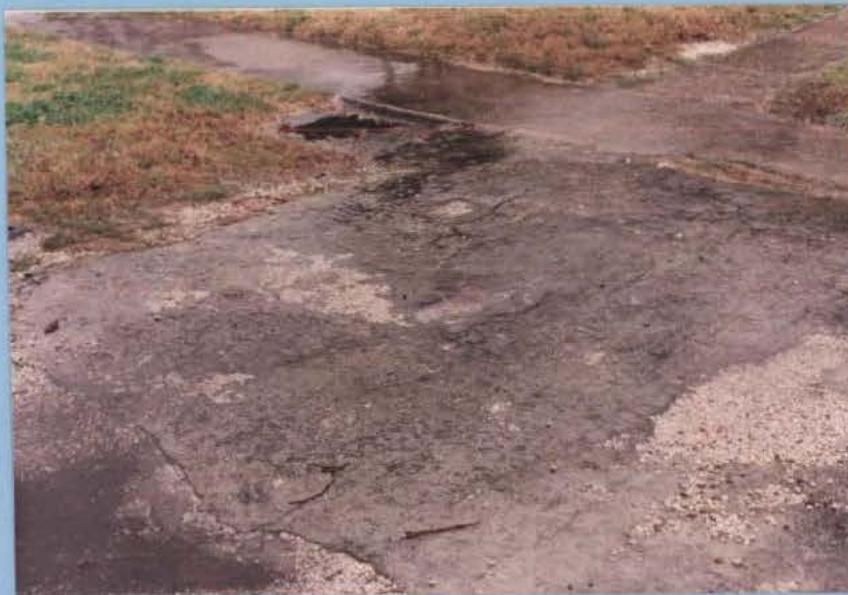
PHOTO#: 18 DATE: 02/08/90
TIME: 1616 DIRECTION: DOWN
PHOTOGRAPHER: J. MARTIN/T. NAQUIN
(b) (6)

ROADFILL AT [REDACTED]
SITE #2

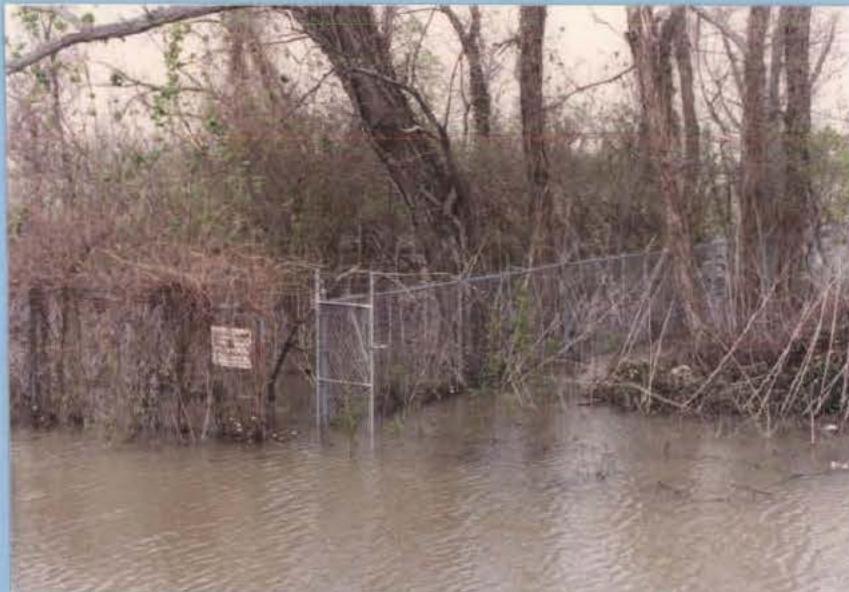
PHOTO#: 20 DATE: 02/28/90
TIME: 1219 DIRECTION: NW
PHOTOGRAPHER: T. NAQUIN/M. EZELL

JOHNS-MANVILLE LANDFILL ALONG THE
MISSISSIPPI RIVER FLOODED WITH HIGH
WATER AND A FENCE WITH AN OPEN GATE

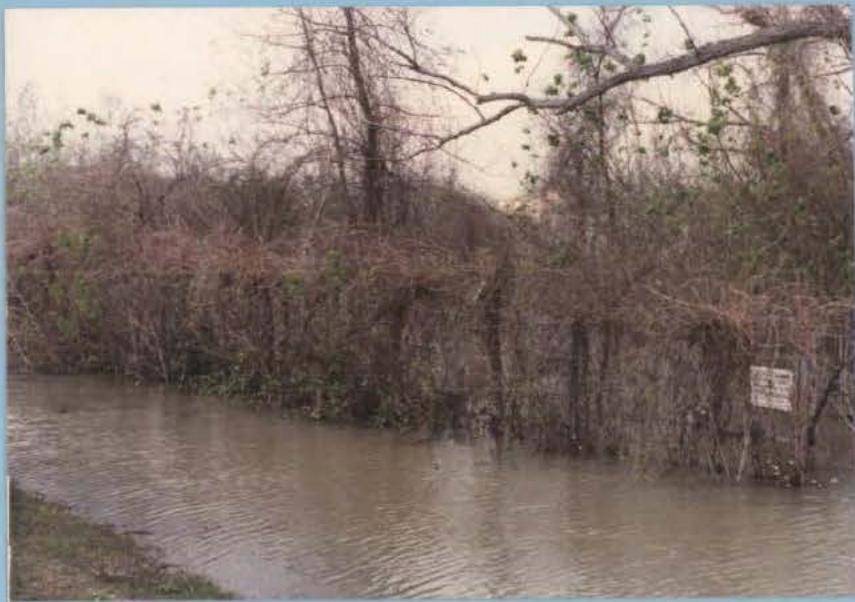
PHOTO#: 21 DATE: 02/28/90
TIME: 1219 DIRECTION: NW
PHOTOGRAPHER: T. NAQUIN/M. EZELL

JOHNS-MANVILLE LANDFILL ALONG THE
MISSISSIPPI RIVER FLOODED WITH HIGH
WATER AND A FENCE WITH AN OPEN GATE

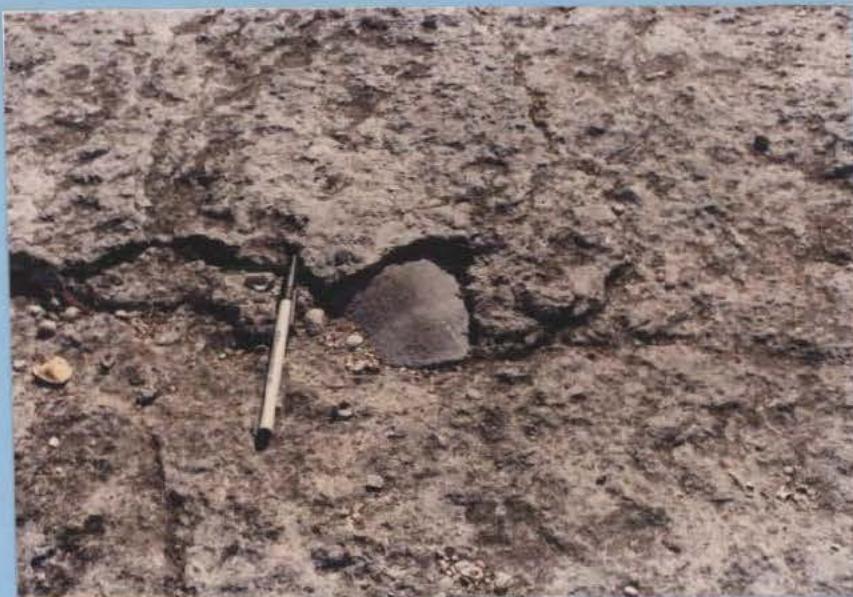
PHOTO#: 22 DATE: 02/28/90
TIME: 0940 DIRECTION: E
PHOTOGRAPHER: T. NAQUIN/M. EZELL

(b) (6) CLOSEUP OF THE [REDACTED] RESIDENCE AT
(b) (6) [REDACTED] DRIVEWAY

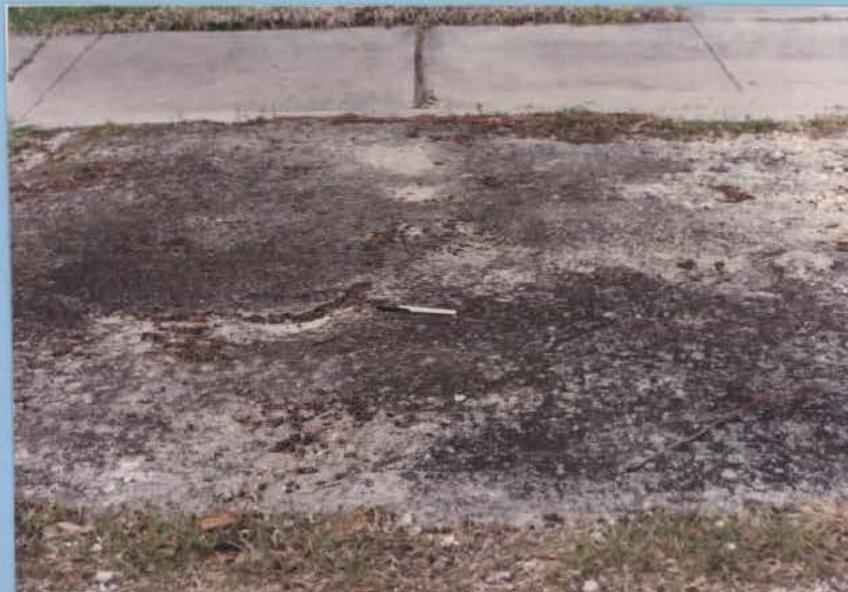
PHOTO#: 24 DATE: 02/28/90
TIME: 1145 DIRECTION: W
PHOTOGRAPHER: T. NAQUIN/M. EZELL

DRIVEWAY (b) (6)

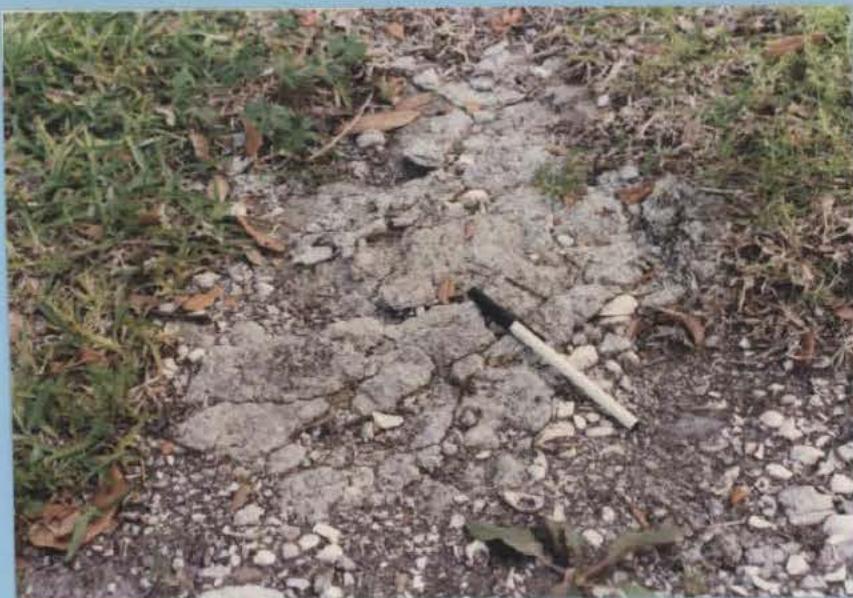
PHOTO#: 25 DATE: 02/28/90
TIME: 1147 DIRECTION: E
PHOTOGRAPHER: T. NAQUIN/M. EZELL

PULP-LIKE MATERIAL FOUND IN BACK
DRIVE [b] (6)

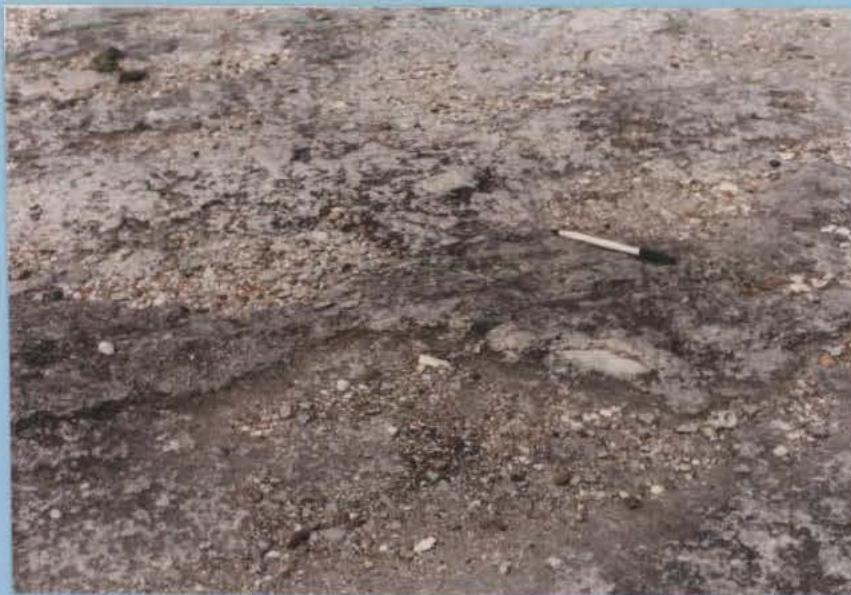
PHOTO#: 27 DATE: 02/28/90
TIME: 1210 DIRECTION: W
PHOTOGRAPHER: T. NAQUIN/M. EZELL

INSIDE SHED AT (b) (6)

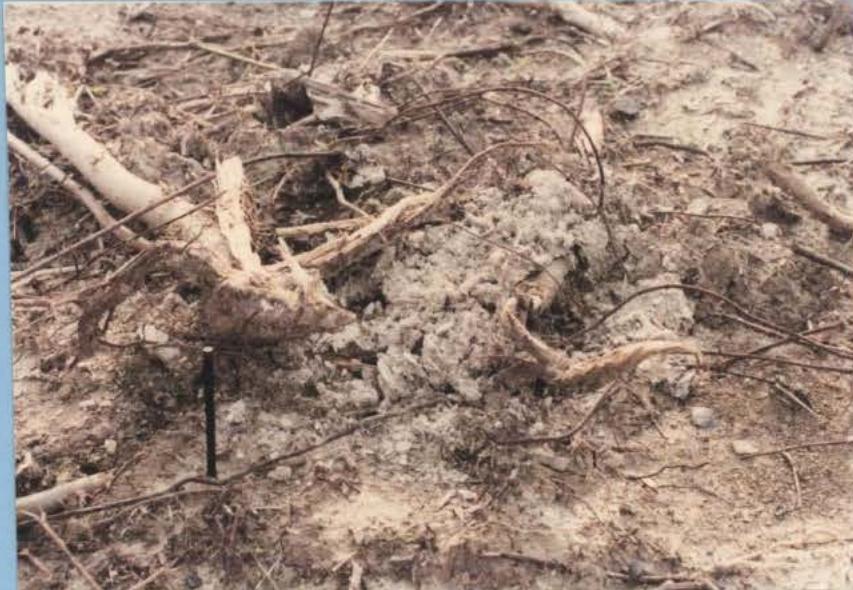
PHOTO#: 29 DATE: 03/07/90
TIME: 1608 DIRECTION: DOWN
PHOTOGRAPHER: T. NAQUIN/M. EZELL

SUSPECT WHITE ACM AT THE LANDFILL ON
LAPALCO BLVD

EPA and TAT investigated an inactive landfill located on LaPalco Boulevard which was once utilized by Johns-Manville. The unfenced site was heavily vegetated and contained household garbage. TAT observed potential ACM at the surface of the landfill which appeared to be in three main forms: 1) a black, asphalt-like material, 2) a light gray to off white, fibrous material, and 3) variegated transite floor and siding tiles (Photograph 29 - 32). Residential communities and businesses are located around the perimeter of the landfill.

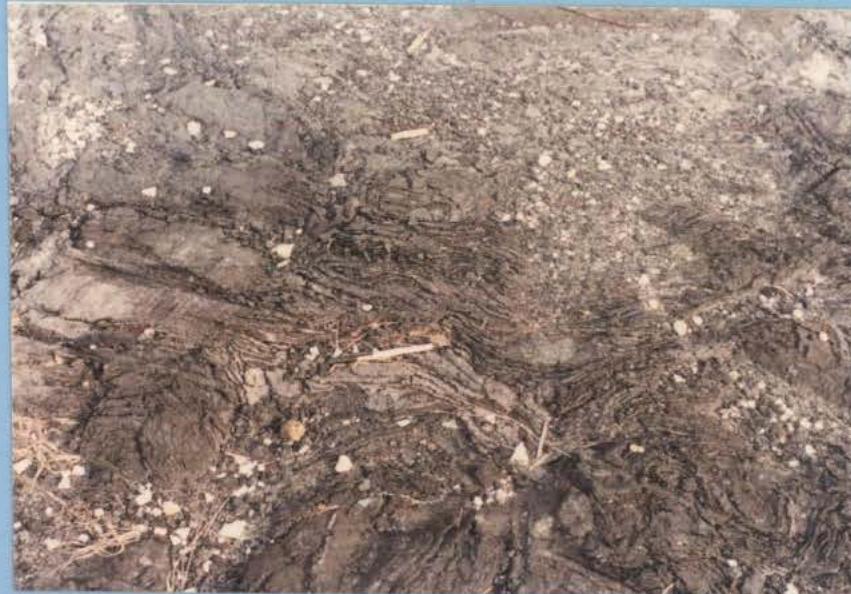
PHOTO#: 30 DATE: 03/07/90
TIME: 1612 DIRECTION: DOWN
PHOTOGRAPHER: T. NAQUIN/M. EZELL

BLACK ROOFING MATERIAL AT THE LANDFILL
ON LAPALCO BLVD

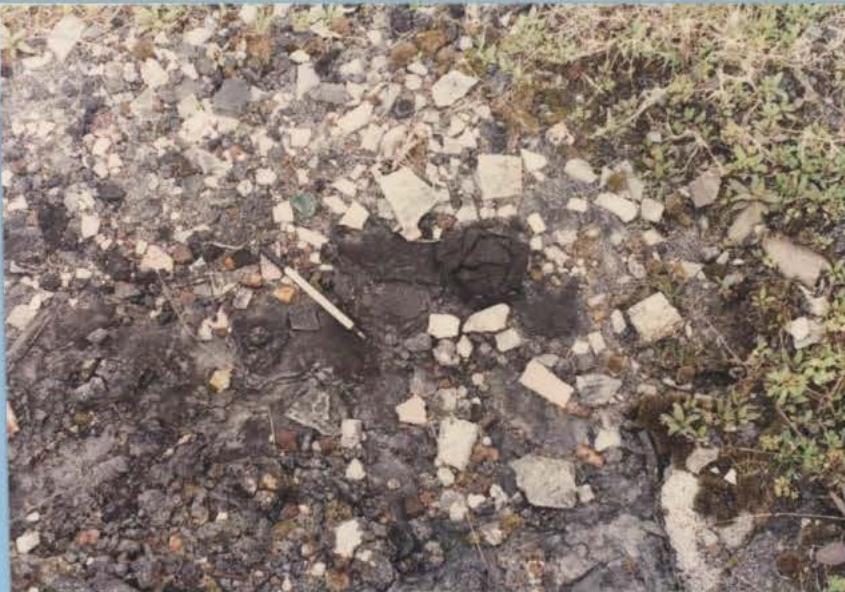
PHOTO#: 31 DATE: 03/07/90
TIME: 1612 DIRECTION: DOWN
PHOTOGRAPHER: T. NAQUIN/M. EZELL

PIECES OF TRANSITE BOARD AT THE
LANDFILL ON LAPALCO BLVD

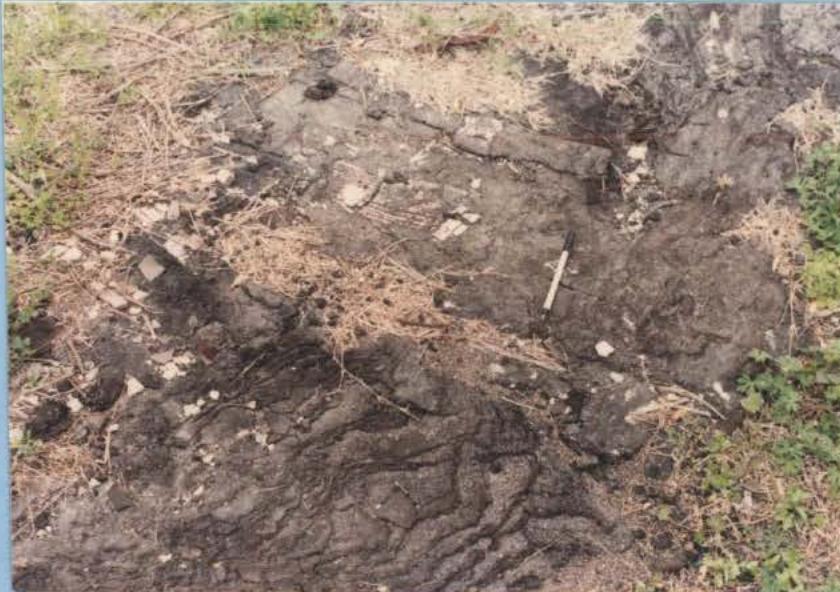
PHOTO#: 32 DATE: 03/07/90
TIME: 1616 DIRECTION: DOWN
PHOTOGRAPHER: T. NAQUIN/M. EZELL

ROOFING AND TRANSITE BOARD MATERIALS
AT THE LANDFILL ON LAPALCO BLVD

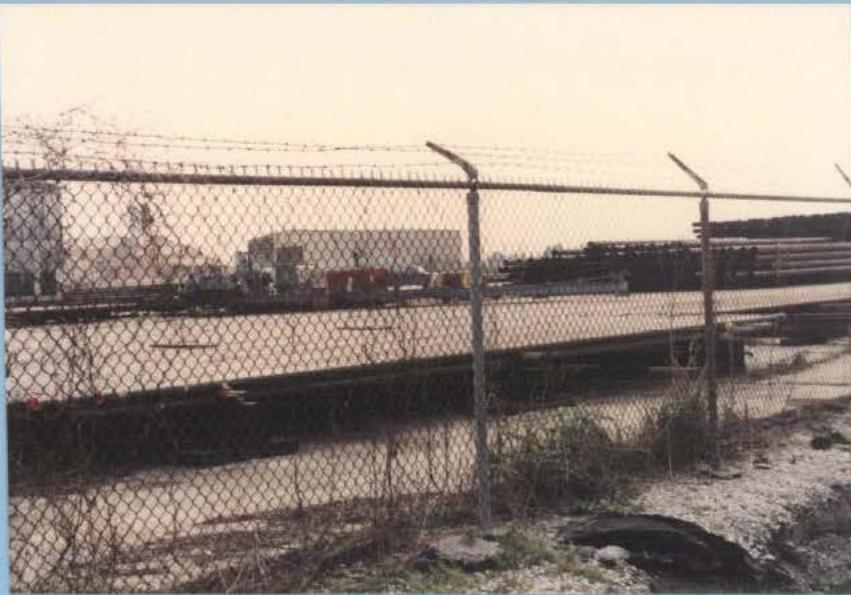
PHOTO#: 33 DATE: 03/08/90
TIME: 1503 DIRECTION: SW
PHOTOGRAPHER: T. NAQUIN/M. EZELL

PIPEYARD NEAR JOHNS-MANVILLE ON RIVER ROAD

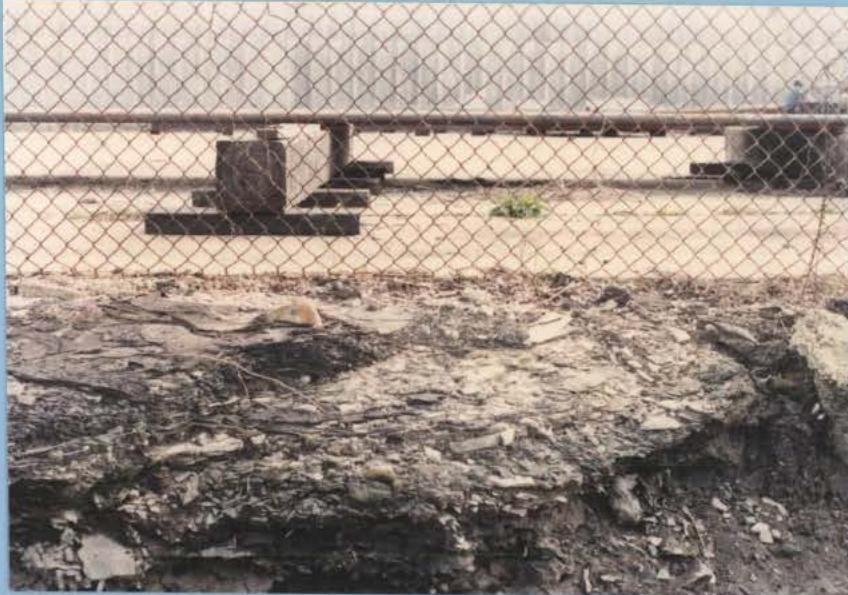
PHOTO#: 34 DATE: 03/08/90
TIME: 1502 DIRECTION: SE
PHOTOGRAPHER: T. NAQUIN/M. EZELL

ROOFING MATERIAL OUTCROPPING BY THE PIPEYARD DITCH ON RIVER ROAD

1456 TAT Naguin & Egall arrive at the John - Manville plant. A pipe yard is presently in operation at the dump site given by OSC John Martin. asbestos containing roofing material was found interspersing near the ditch between River Road and the pipe yard.

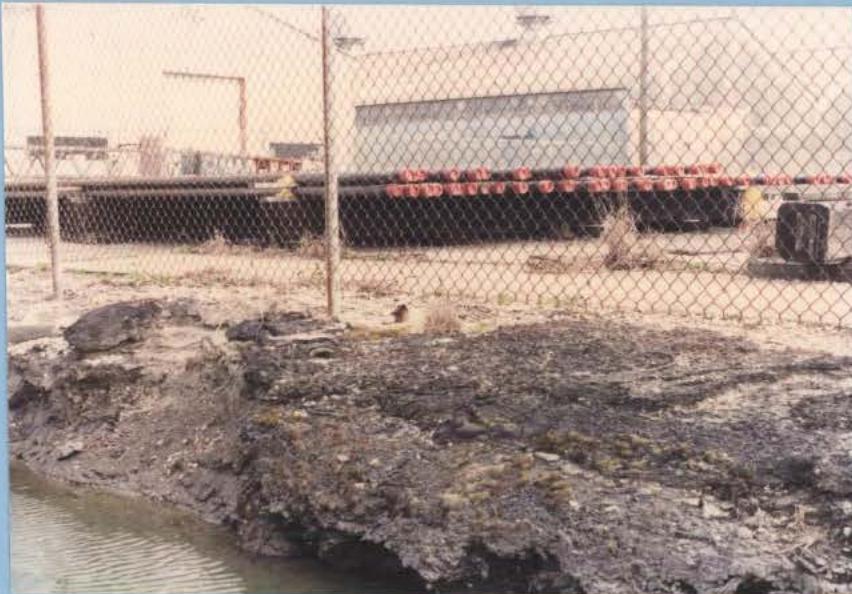
PHOTO#: 35 DATE: 03/08/90
TIME: 1502 DIRECTION: SE
PHOTOGRAPHER: T. NAQUIN/M. EZELL

ROOFING MATERIAL OUTCROPPING BY THE
PIPEYARD DITCH ON RIVER ROAD

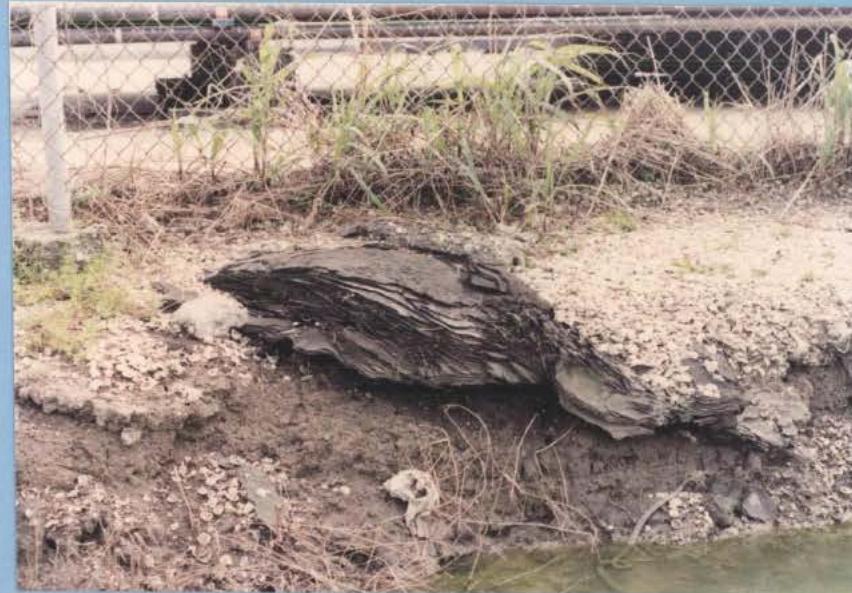
PHOTO#: 36 DATE: 03/08/90
TIME: 1502 DIRECTION: S
PHOTOGRAPHER: T. NAQUIN/M. EZELL

BLACK, LAYERED ROOFING MATERIAL
OUTCROPPING AT PIPEYARD DITCH ON RIVER
ROAD

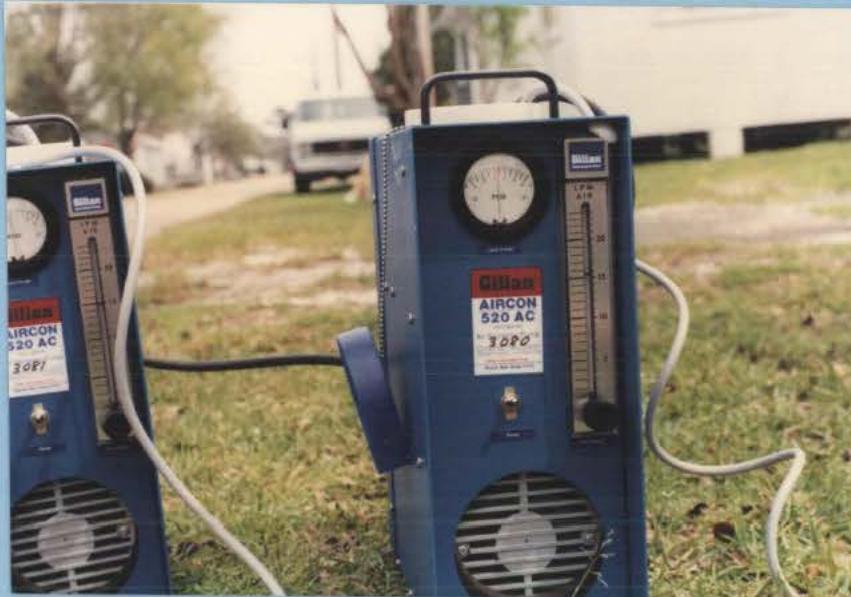
PHOTO#: 37 DATE: 03/07/90
TIME: 1309 DIRECTION: E
PHOTOGRAPHER: T. NAQUIN/M. EZELL

GILIAN PUMPS SAMPLING 15 L/min

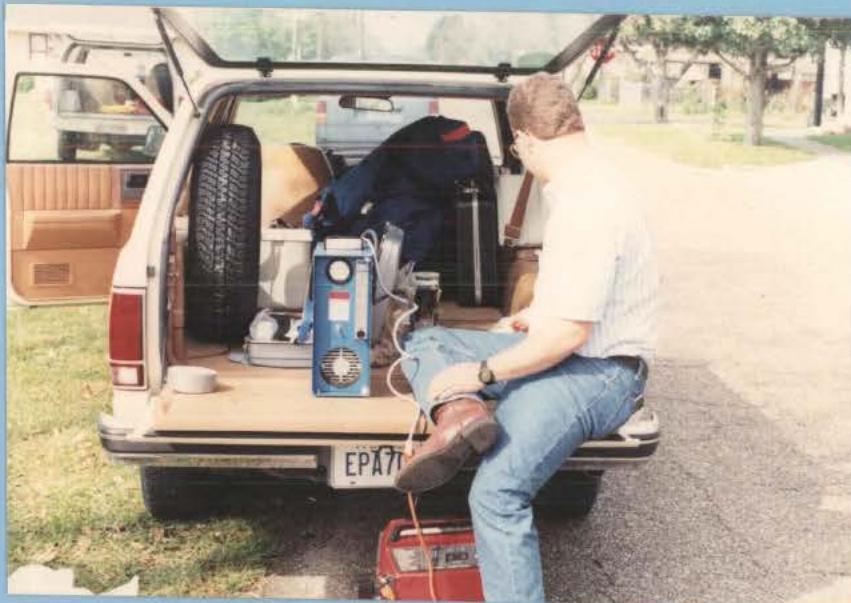
PHOTO#: 38 DATE: 03/07/90
TIME: 1034 DIRECTION: NW
PHOTOGRAPHER: T. NAQUIN/M. EZELL

CALIBRATION OF PUMPS WITH GILIBRATOR

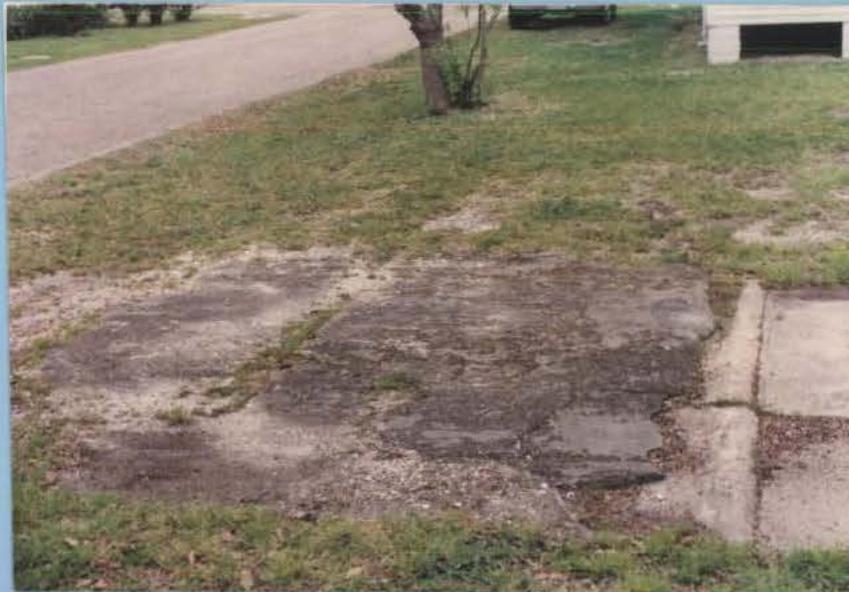
PHOTO#: 40 DATE: 03/07/90
TIME: 1307 DIRECTION: E
PHOTOGRAPHER: T. NAQUIN/M. EZELL

ACM AREA IN BACK [REDACTED]
BEING SAMPLED (b) (6)

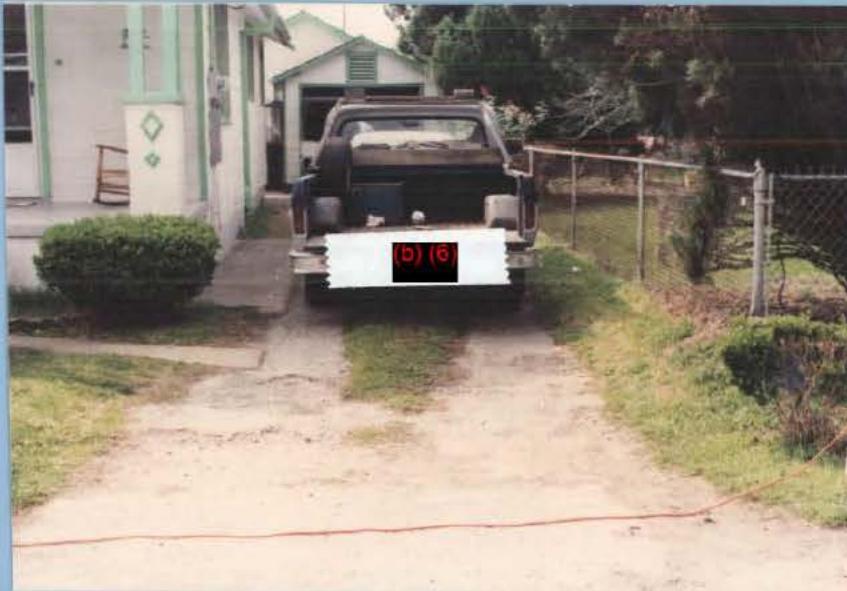
PHOTO#: 41 DATE: 03/07/90
TIME: 1305 DIRECTION: S
PHOTOGRAPHER: T. NAQUIN/M. EZELL

AIR SAMPLING A (b) (6)

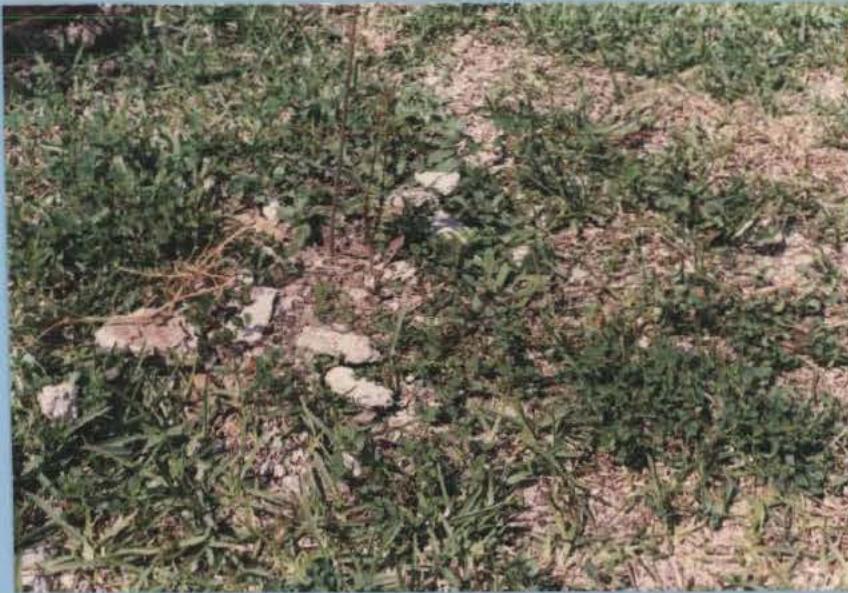
PHOTO#: 44 DATE: 02/28/90
TIME: 1212 DIRECTION: NW
PHOTOGRAPHER: T. NAQUIN/J. SHARP

ACM FOUND IN BACKYARD OF [REDACTED] (b) (6)
STREET

TAT + DEQ that the ACM was found in his back
 yard and he had to dig through the material in
 order to plant a small tree.

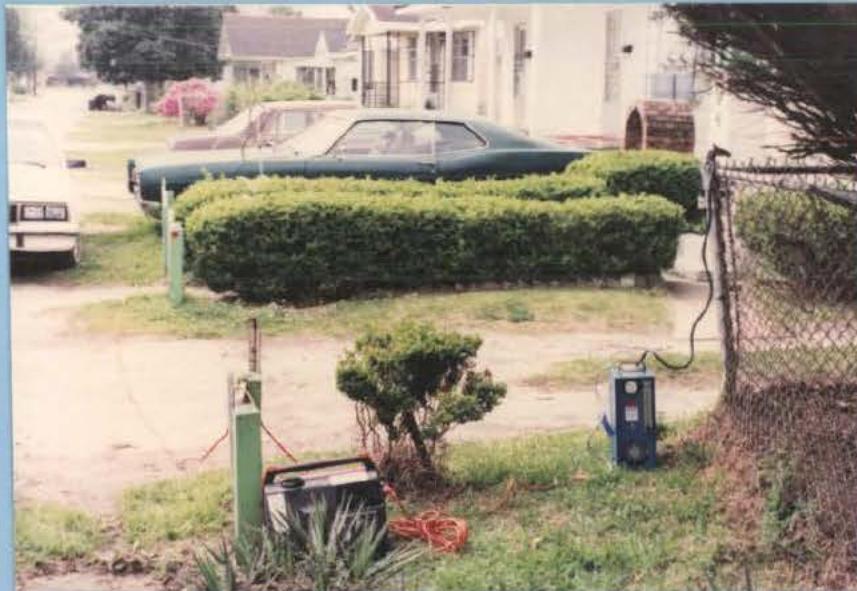
PHOTO#: 45 DATE: 02/28/90
TIME: 1206 DIRECTION: N
PHOTOGRAPHER: T. NAQUIN/E. EZELL

REAR OF DRIVEWAY NEAR SHED (b) (6)
(b) (6) STREET

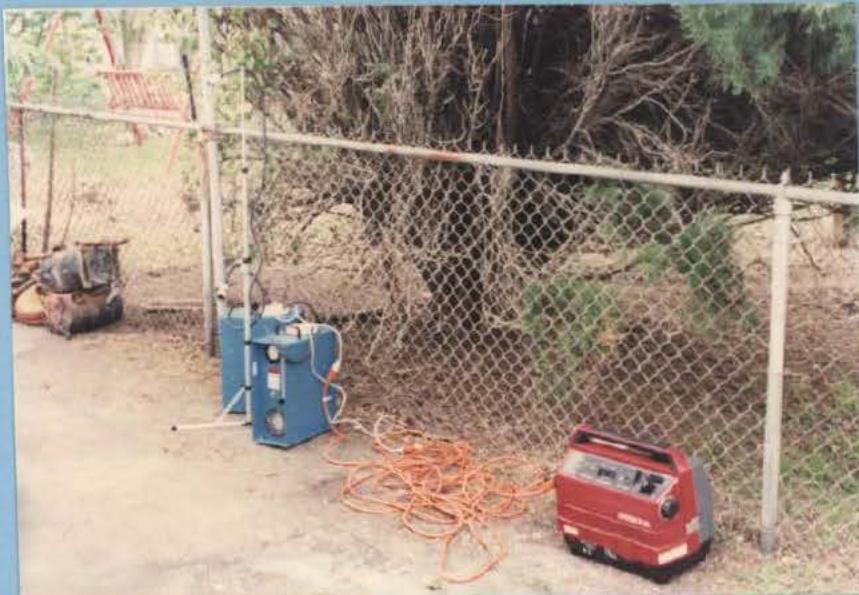
PHOTO#: 46 DATE: 03/08/90
TIME: 1033 DIRECTION: S
PHOTOGRAPHER: T. NAQUIN/M. EZELL

FRONT AREA/UPWIND SAMPLE LOCATIONS AT
(b) (6) SET

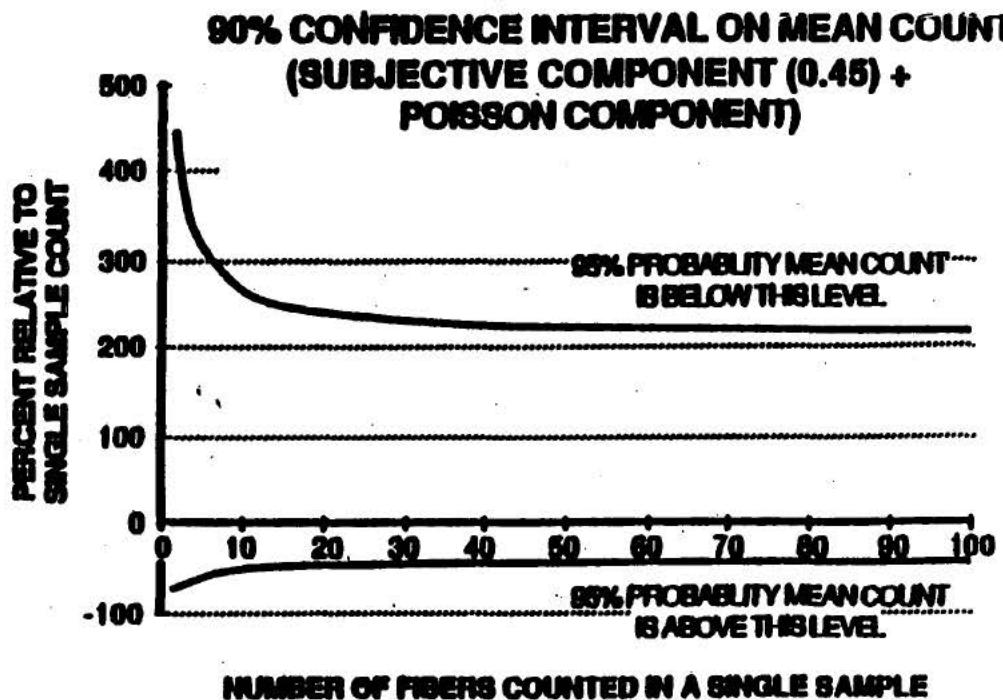
Figure 1. Interlaboratory Precision of Fiber Counts

It can be seen from Figure 1 that the Poisson component of the variability is not very important unless the number of fibers counted is small. Therefore, a further approximation is to simply use +213% and -49% as the upper and lower confidence values of the mean for a 100-fiber count.

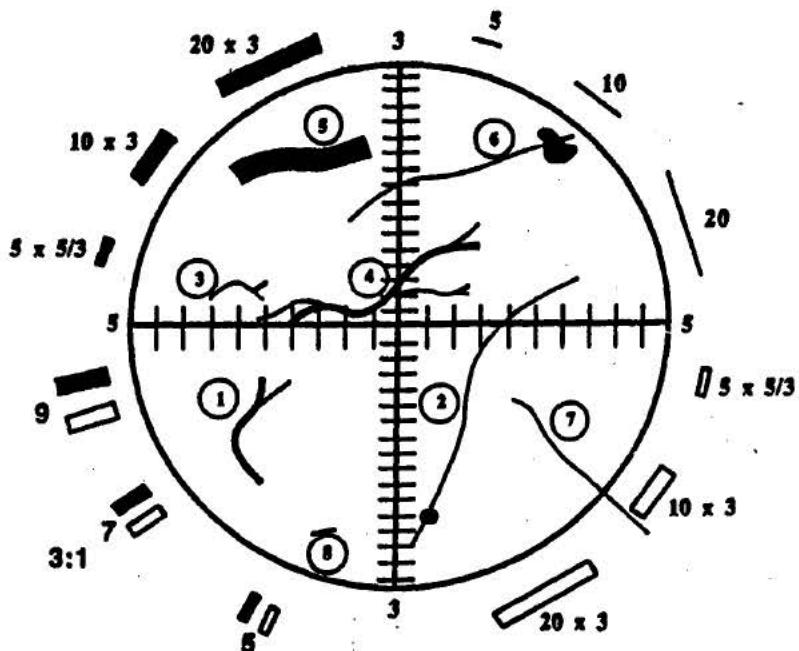
Figure 2. Walton-Beckett graticule with fibers.

Figure 2 shows a Walton-Beckett graticule as seen through the microscope. Although the graticule incorporates the 3:1 aspect ratio, both the "A" and "B" rules will be discussed as they apply to the labeled fibers in the figure.

<u>FIBER COUNT</u>			<u>DISCUSSION</u>
<u>Fiber</u>	<u>A Rules</u>	<u>B Rules</u>	
1	1 fiber	3 ends	(A) "A" rules do not allow for split ends; therefore, count one fiber. (B) Under 'B' rules, first determine whether the fiber meets dimensional criteria, (i.e., $>5 \mu\text{m}$, $>3:1$ aspect ratio, $<3 \mu\text{m}$ diameter). Next determine and count which two ends are the main trunk of the fiber. Finally, count all split ends $>5 \mu\text{m}$ as one end. Fiber #1 is counted as 3 ends.
2	1 fiber	2 ends	(A) Single fiber with small particle attached. The particle is treated as if it does not exist by the "A" rules. (B) The particle is $<3 \mu\text{m}$ diameter and therefore ignored under "B" rules.
3	1 fiber	2 ends	(A) As with Fiber 1, count one fiber under "A" rules because it meets the $>3:1$ aspect ratio, $>5 \mu\text{m}$ criteria. (B) The split end is $<5 \mu\text{m}$ long so it is not counted under "B" rules.
